No Further Action Decision Under CERCLA Study Area 16: Shoppette Debris Disposal Area

Fort Devens Main Post Site Investigation Fort Devens, Massachusetts

Revision 1 January 1995

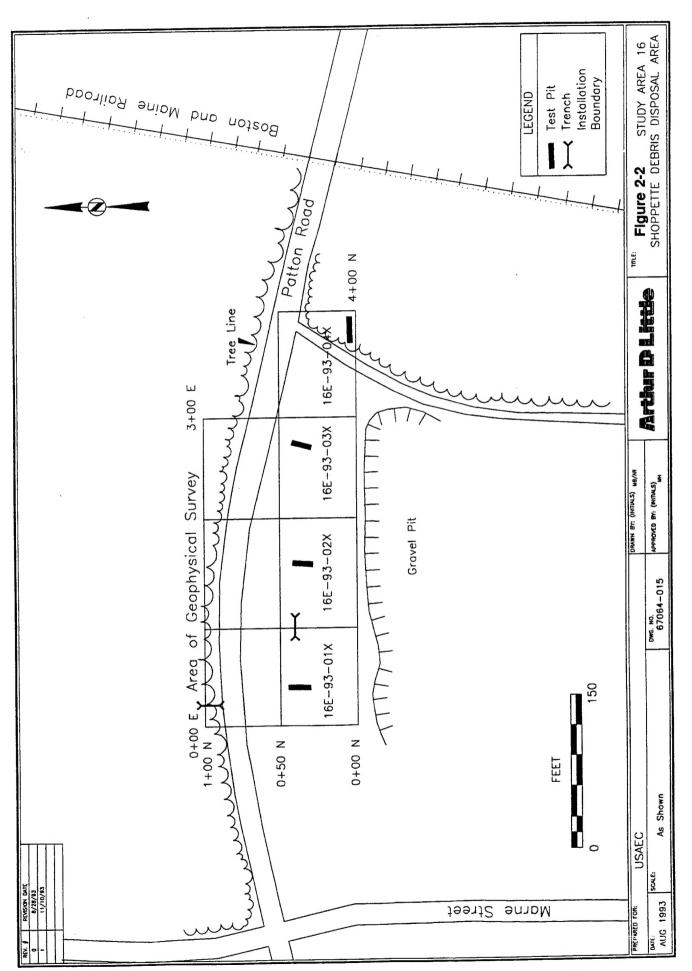
| 1 | List of Figures | <b>;</b> |
|---|---|--|
| 4 | Figure 2-2: | SA-16 Shoppette Debris Disposal Area |

36 37 The Shoppette Debris Disposal Area (SA-16) is located east of Marne Street and south of Patton Road. The disposal area is bounded on the east by an intermittent stream, the Fort Devens installation boundary, and the Boston & Maine Railroad tracks. The study area encompasses approximately 1 acre along the northern edge of an inactive gravel pit (Figure 2-2).

A combination magnetic and terrain conductivity survey was performed throughout an approximately 2-acre portion of SA-16 (Figure 2-2) to evaluate the potential presence and extent of buried debris. The results of the magnetic and electromagnetic geophysical surveys did not indicate the presence of an anomalous area coincident with the reported historical debris disposal practices. Three small anomalies were detected by both geophysical techniques but were subsequently determined by ground checks to correspond with surface metal (i.e., fence posts, steel cable, and a wheel rim). The location of the geophysical grid is shown on Figure 2-2.

Four test pits were excavated at the study area, distributed within the area reportedly used for disposal. Three of the test pits were also located at geophysical anomalies to confirm that additional metallic debris was not present beneath the detected geophysical anomalies and one test pit was centrally located to evaluate the potential for disturbed or backfilled materials. Additionally, one shallow trench was excavated through each of two surficial piles of soil fill material to determine if materials other than soil were present in these piles. No unnatural debris or refuse was encountered in any of the test pits or trenches. The stratigraphic horizons identified in the test pits, which were excavated to a maximum depth of 16 feet, appeared to be undisturbed. No ground water was encountered. The locations of the test pits and trenches are shown on Figure 2-2.

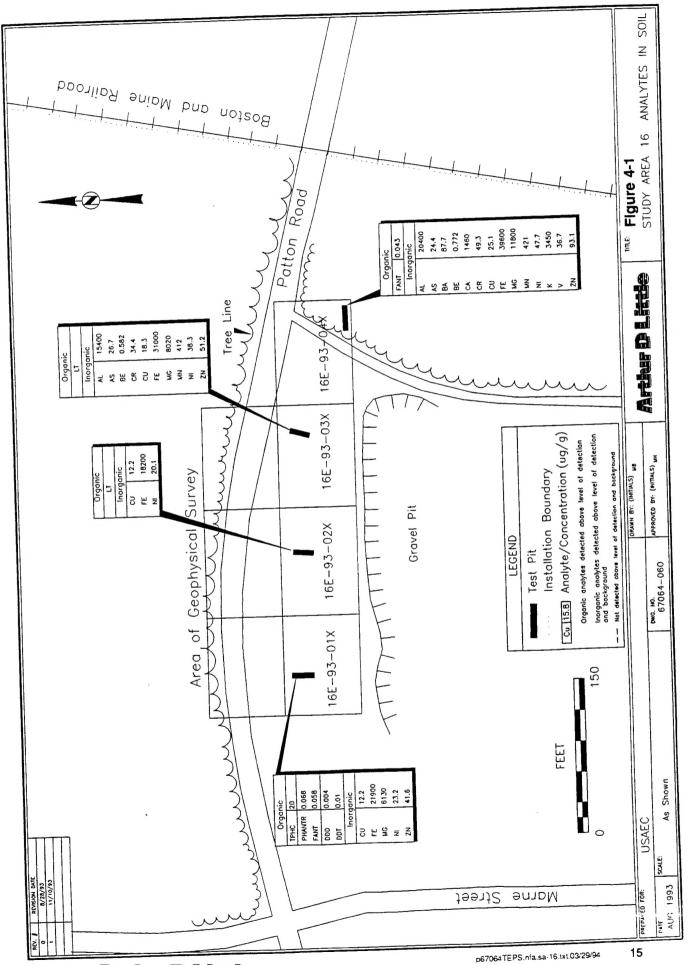
| 1 | List of Figures | <b>;</b> |
|---|---|--|
| 5 | Figure 4-1: | SA-16 Analytes in Soil |

No VOCs were detected in the samples (Table 4-1). Trace concentrations of SVOCs were detected in two of the four test pits: phenanthrene and fluoranthene were detected in 16E-93-01X, and fluoranthene was detected in 16E-93-04X. Trace concentrations of TPHC and the pesticides DDD and DDT were detected in one of the four test pits (16E-93-01X). These concentrations are at the low end of the Fort Devens pesticide background range. Metals were detected above background concentrations at all four test pits.
